# Balchin's *Victory* (Site 25C): Shipwreck Monitoring & Cannon Impacts, 2008-2012

Monitoring in 2008, 2011 and 2012 of the wreck of Balchin's *Victory*, lost in the western English Channel on 5 October 1744, and discovered by Odyssey Marine Exploration in 2008, has provided new comparative primary archaeological data about the site's natural deterioration and man-made impacts. In addition to lost sections of hull planking, numerous bronze guns display scratches, abraded surfaces, concretion breakage and have been displaced from their 2008 recorded positions. Two guns feature recently severed muzzles and at least one cannon has been illicitly salvaged since 2008.

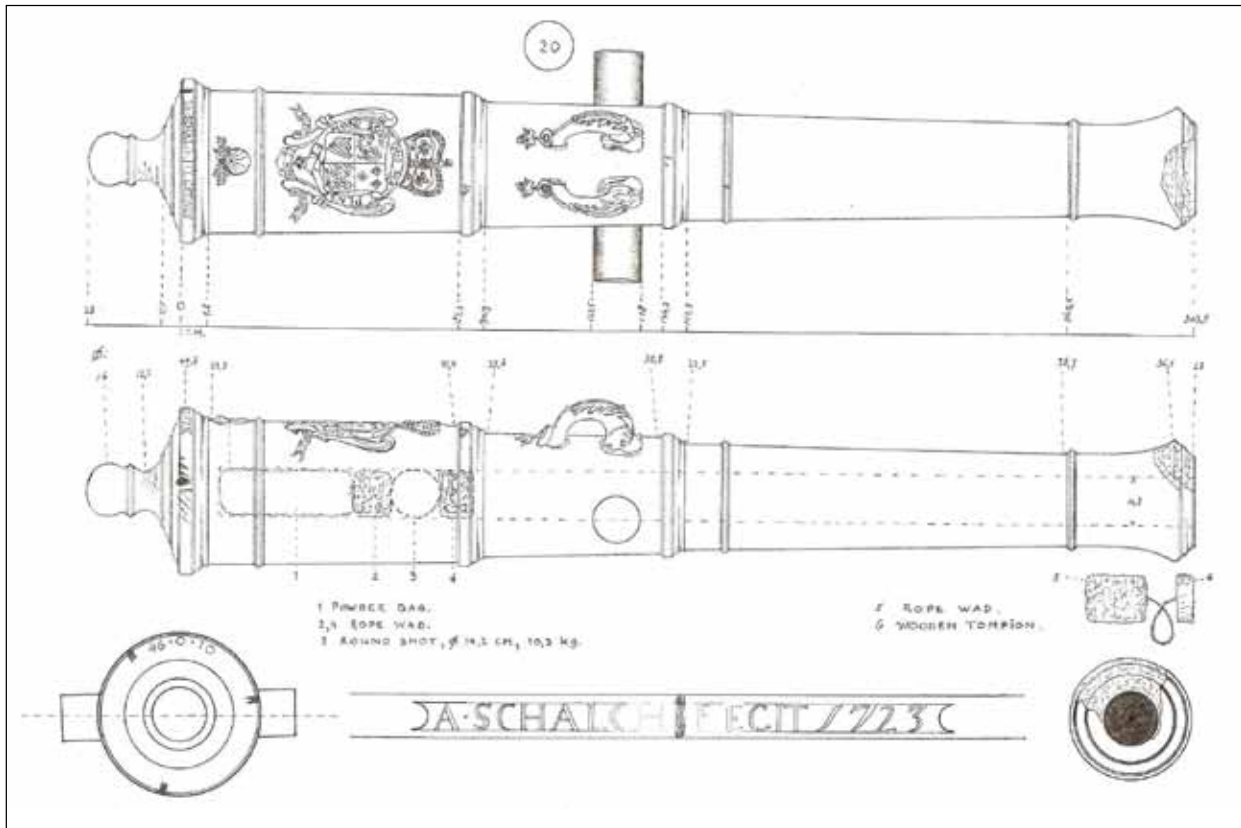
Information was received on 30 October 2011 that a Dutch vessel had illegally salvaged a cannon from the wreck of Balchin's *Victory* in July 2011. Usually engaged in recovering lost cargos, anchors and metals from wrecks, the salvage company removed a 24-pounder bronze cannon using a camera-installed hydraulic grab bucket (Fig. 3). Cannon specialist Nico Brinck examined the gun and confirmed through royal arms and stamps, specifically the founder's name 'SCHALCH' followed by the date '1723', its association with Balchin's *Victory* (independently identified as probably C13 from Area D, which correlates with on-site 2012 observations: Figs. 43-46). Mr Brinck's measurements reveal the following dimensions for the cannon (Fig. 4):

- L. 303.5cm
- Base ring Diam. 49.7cm
- Muzzle swell Diam. 36.5cm
- Trunnion Diam. 14.5cm
- Bore Diam. 14.8cm

Figs. 3-4. Photo and drawing of the 24-pounder bronze cannon illicitly salvaged from the *Victory* in July 2011, inscribed 'Schalch' and '1723'. Believed to be C13 from Area D. Drawing: by and courtesy of Nico Brinck.

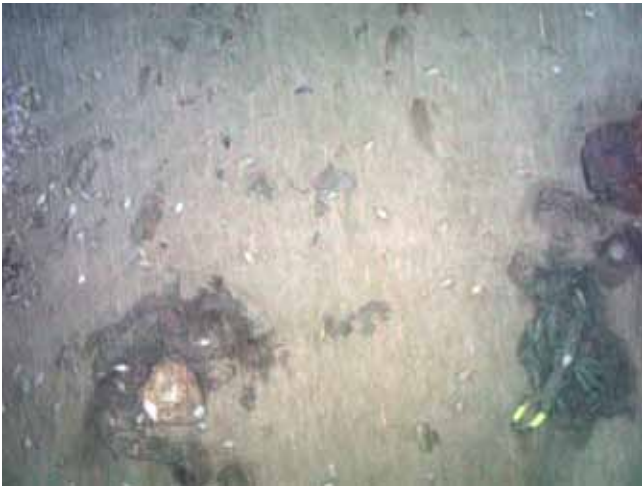
Fig. 5. Fishing cable snagged in Area D (February 2012).

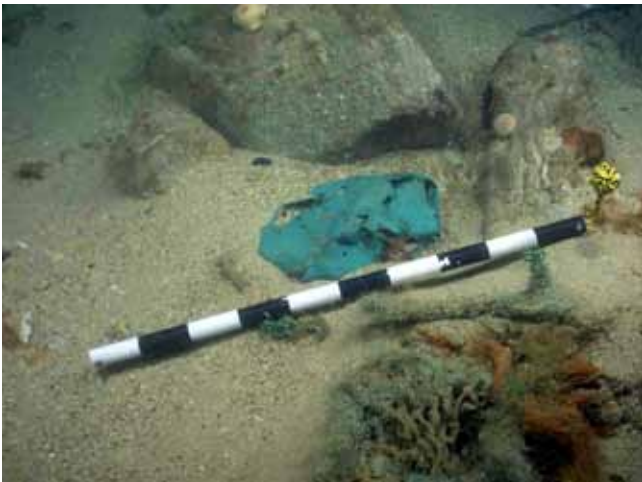
Fig. 6. Fishing cable snagged in Area F (February 2012).

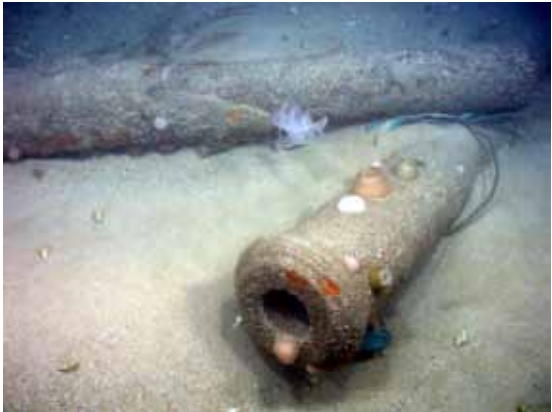
<p><b>Class A</b> Bronze guns entirely covered with a consistent thickness of concretion. Surfaces commonly populated by sea grass and biological matter, including biofouling.</p>

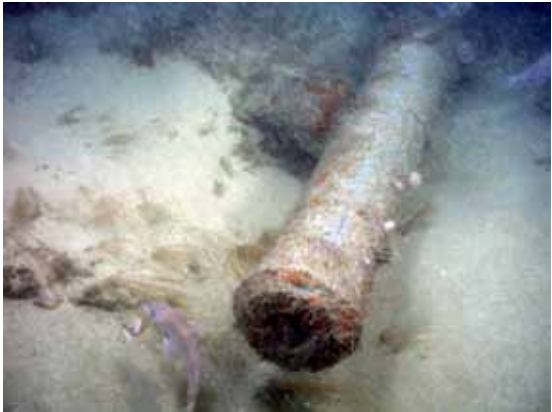
<p><b>Class B</b> Completely concreted cannon displaying linear scratches cut through the encrustation shell or very minor patches of displaced concretion.</p>

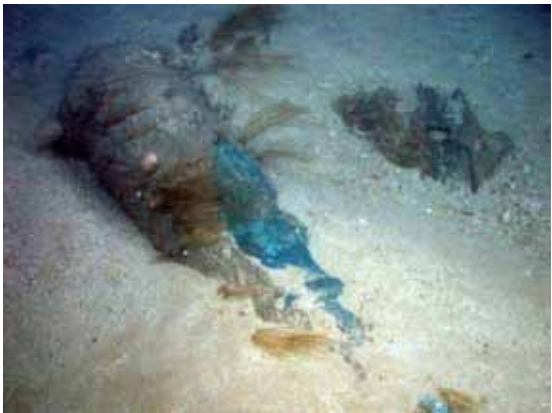
<p><b>Class C</b> Guns exhibiting extensive encrustation, alongside large sections of exposed bronze surfaces, where the encrustation has been knocked/abraded off. On site 25C the exposed bronze areas on Class C cannon generally occur on the upper surfaces; structurally protected gun components, typically the vertical mouth of the muzzle and trunnions, tend to retain their concretion cover.</p>

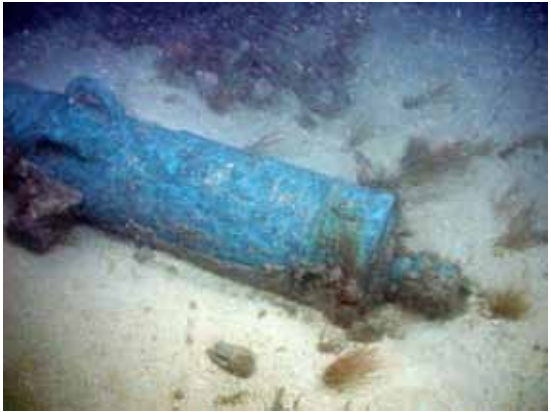
<p><b>Class D</b></p> <p>Guns displaying a distinct bipartite pattern, whereby the underside (usually including at least one trunnion), physically interacting with sediments, remains covered with concretion but the upper surface exposed to the water column is almost entirely stripped of its concreted veneer.</p>

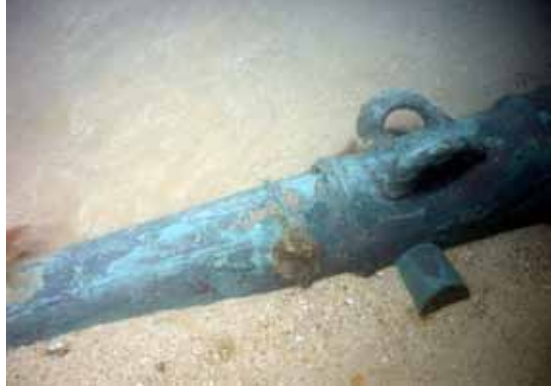
<p><b>Class E</b></p> <p>Bronze guns almost completely devoid of concretion and biofouling, frequently associated with extensively abraded upper surfaces intercut with linear scratches. Small patches of concretion may survive on muzzle mouths, trunnions or reinforce rings, seemingly reflecting the former recent concreted condition of the gun.</p>

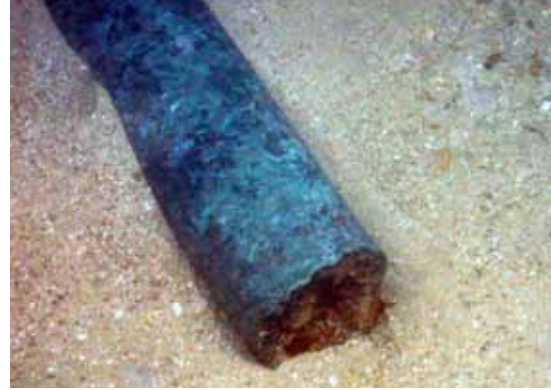
<p><b>Class F</b></p> <p>Examples of guns where the muzzle has been completely severed vertically and the broken component is no longer visible on site 25C. Such cannon otherwise display Class B/C forms of incomplete concretion, but with a complete absence of concretion covering the impacted muzzle end.</p>

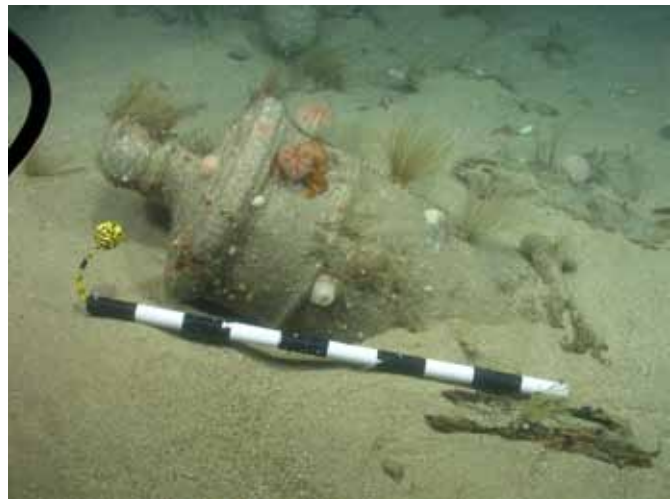
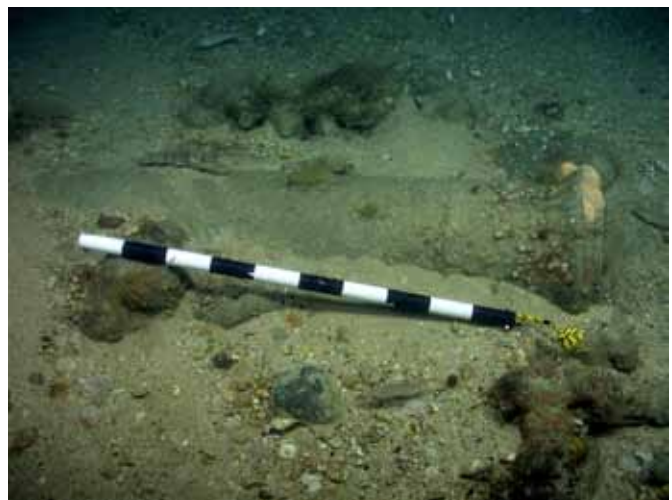
Figs. 7-8. Bronze cannon C11 (top) in Area D and C31 in Area F (bottom) with continuous concretion cover and marine life (Class A).

Class A seemingly represents the typical condition of the cannon on site 25C under natural undisturbed circumstances, where the artifact's entire surface is covered with a thin, but hard concretion layer (Figs. 7-8). The metal's microenvironment includes marine growth in the form of sea anemones (*Actinauge richardi*), plumose anemones (*Metridium senile*), dead men's fingers (*Alcyonium digitatum*) and green or edible sea urchins (*Psammechinus miliaris* or *Echinus esculentus*). If left undisturbed by human intervention the majority of the bronze cannon on the *Victory* site would seemingly adhere to Class A levels of marine growth.

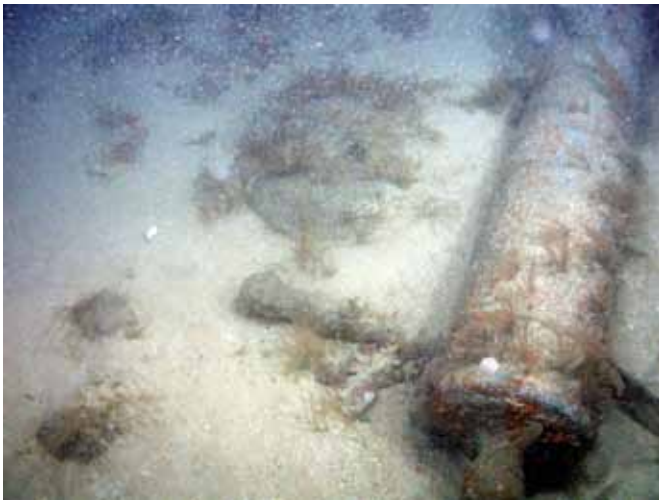
Fig. 9. Cannon C4 in Area C1 as displaced in October 2011, with continuous concretion other than breakage to its exposed trunnion (Class B).

Area	Cannon No.	2008	April 2011
C2	C4	Bearing 35°, facing northeast, stone gunner's wheel immediately to west.	Orientation changed to 112°, facing southeast, gunner's wheel to north.

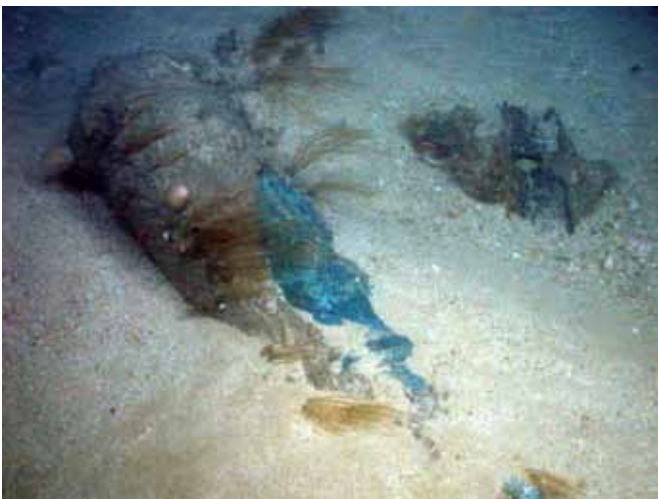
Fig. 10. Cannon C29 in Area G with a well-formed concretion, but broken off on its exposed upper surface over the royal arms resulting in fresh elements of corrosion (Class C).

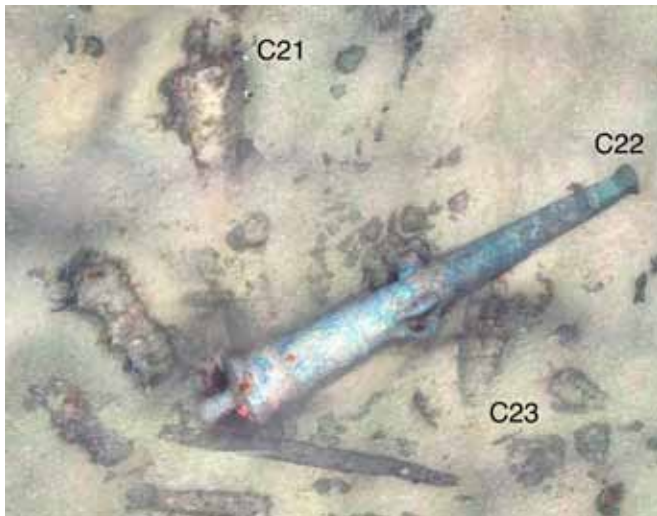
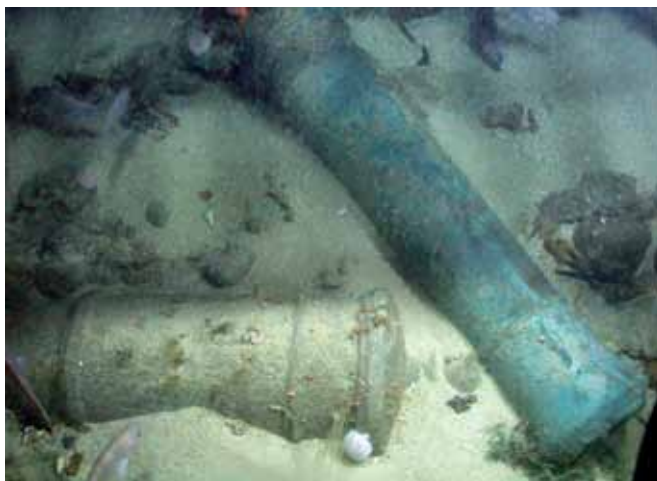
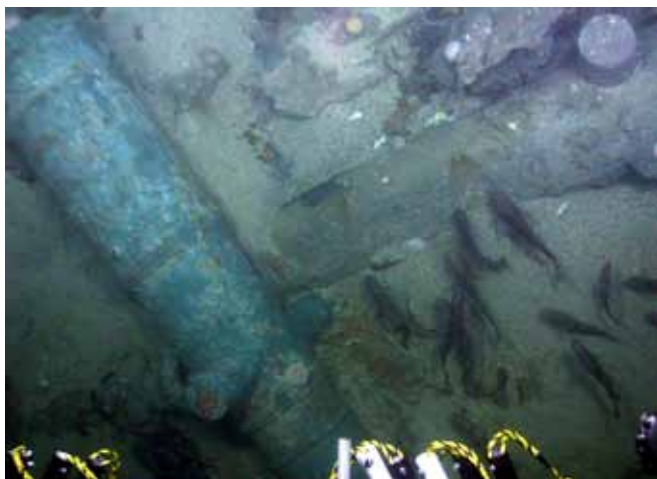
Figs. 11-13. The context of cannon C22 in Area E in 2008 (top) and in April 2011 (middle and bottom) reveals the gun to have been displaced 1.5m to the southwest. Note the positional differences in 2011 between C22 in relation to the cascabel of C23 (middle left) and to the chase of C21 (bottom right). The plank present next to C22 in 2008 had disappeared in 2011. C21: Class B; C22: Class D; C23: Class A. For more detailed graphic representation of this gun cluster, see Figs. 47-51.

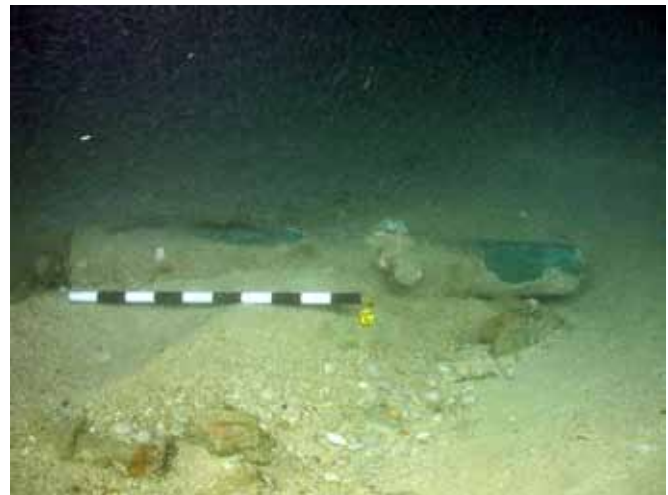
Fig. 14. Cannon C29 in Area G sitting on the seabed surface with sediment accumulating to its southwest. Extensive concretion broken off the upper surfaces (Class D).

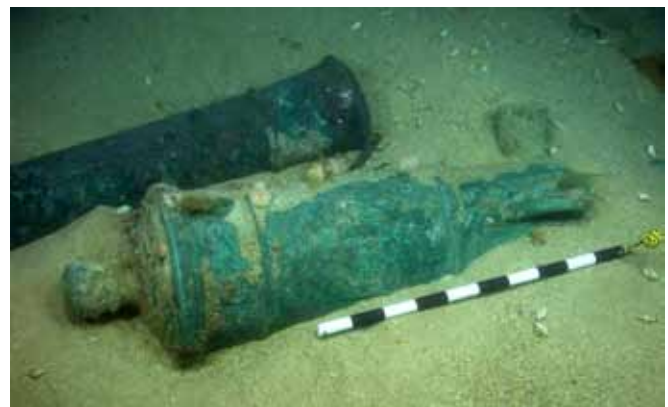
Fig. 15. Cannon C7 (right, Class C) and C8 (left, Class E) from Area B1.

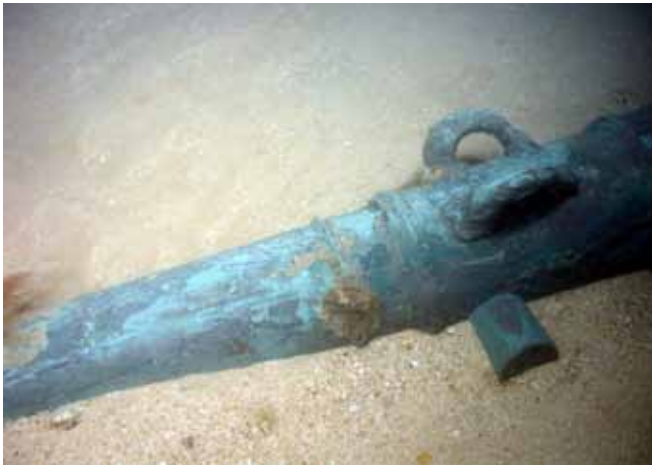
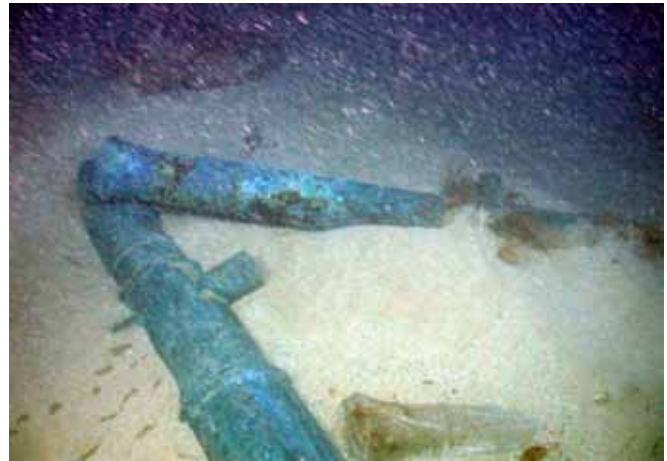
Figs. 16-17. Deep scratches, abrasion marks and corrosion products on cannon C5 in Area A formed since 2008 (Class E).

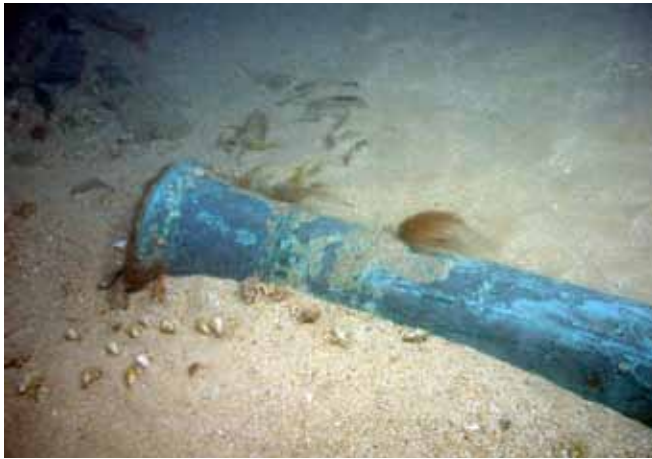
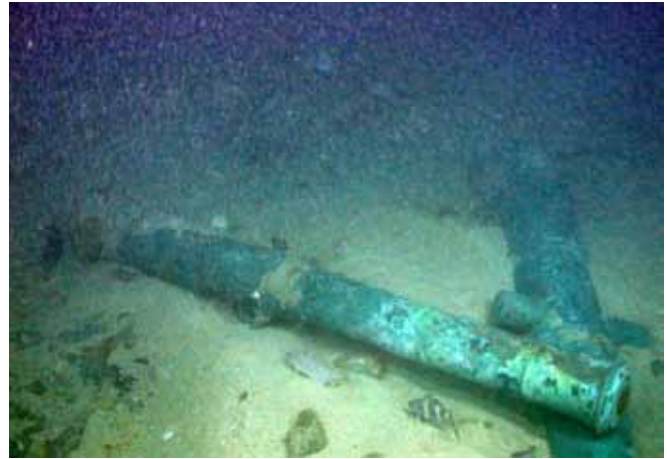
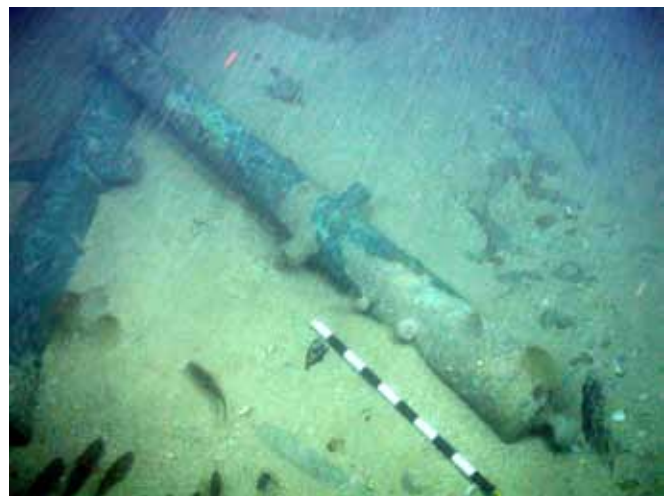
Figs. 18-20. A group of three cannon (C1, C2, C34) in Area A. C2 was displaced from the southwest to overlie C1 between 2008 and April 2011 (see Figs. 28-31). The first reinforce of C1 and chase of C2 (Class E) are heavily scoured and abraded, while two scratches are present on the muzzle and chase of C34 (Class B). Extensive evidence of corrosion caused by multiple exposure and non-exposure to oxygen, marine life and gun displacements indicates that site 25C is not stable, but subject to substantial changes in the physical, chemical and biological environment.

Area	Cannon No.	2008	April 2011
A	C2	Bearing 14°, 3.1m southeast of C1's button.	Relocated 4.8m northeast, overlying C1 mid-chase, bearing 6°.

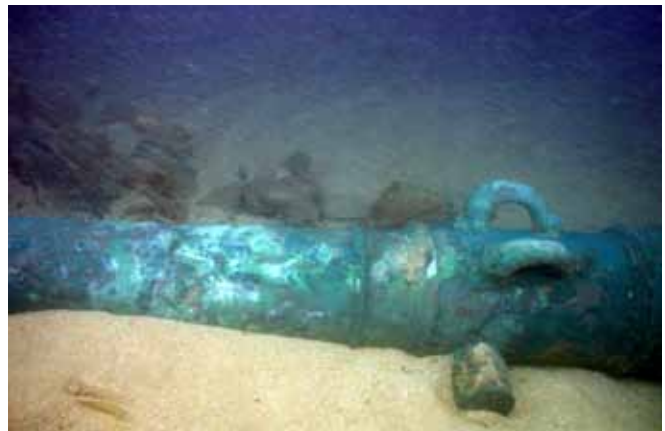
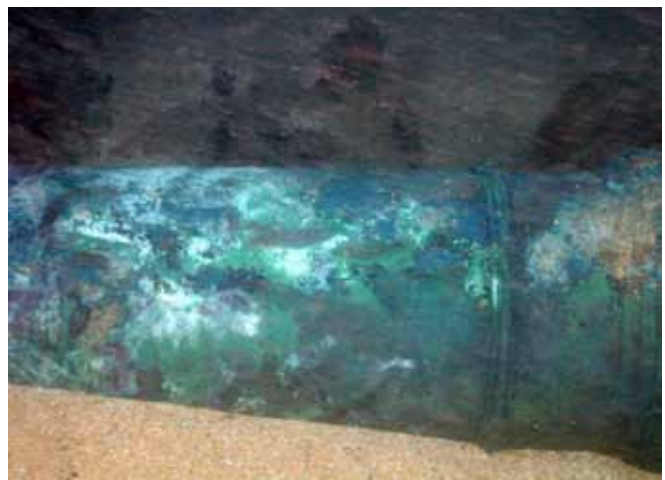
Figs. 21-22. Cannon C20 dragged 8.5m from Area B1 to Area E between 2008 and April 2011. The gun is heavily abraded and covered with scratches and fresh corrosion products (Class E).

Area	Cannon No.	2008	April 2011
E	C20	Not present.	New cannon, bearing 239°, facing southwest, heavily scoured chase. Believed to be C20 relocated 8.5m from northeast in Area B1.
E	C21	Bearing 168°, facing south, muzzle underlying C22 breech and vent field.	Rotated 45° to west bearing 158°, muzzle underlying C22 second reinforce.
E	C22	Bearing 63°, facing northeast, breech and vent field overlies C21 chase; 2.7m-long wooden spar immediately at south.	Rotated 90° to southeast bearing 56°, second reinforce overlies C21 muzzle. Gun shunted 1.5m to southwest. Wooden spar not present.

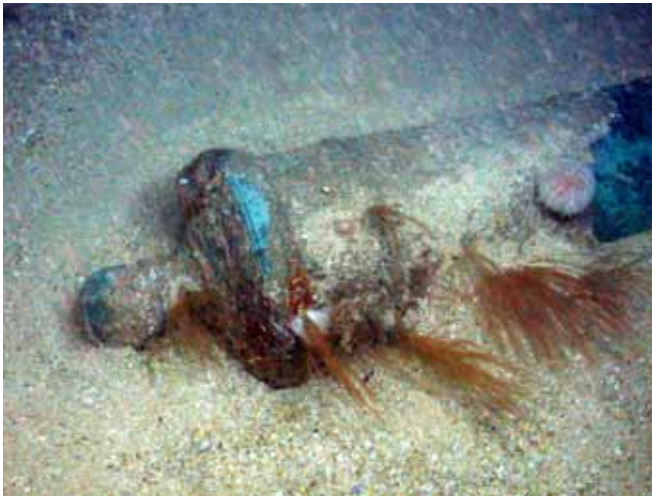
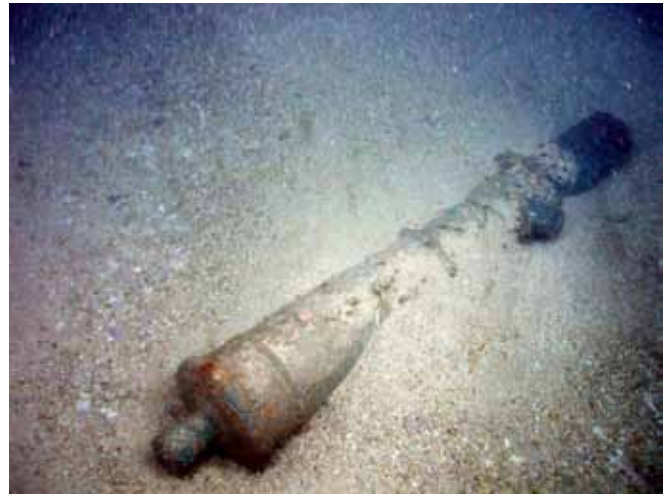
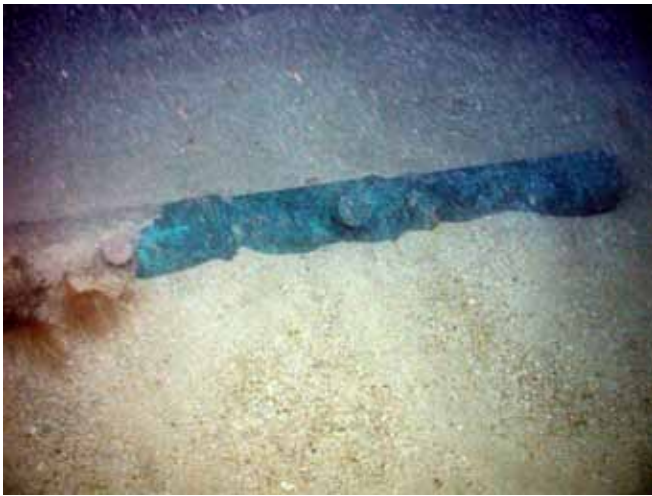
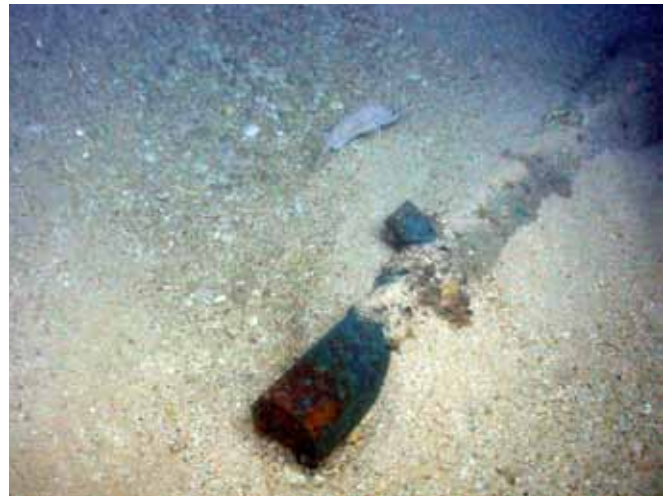
*Figs. 26-27. Bronze cannon C27 in Area G with concrete broken off the trunnion and chase (Class C). The muzzle has been completely severed (Class F). This breakage occurred prior to 2008.*

severed (Class F: C26 and C27 Figs. 23-27). Their broken sections have not been detected elsewhere on site 25C. An explanation for this damage is that with most of the parts of the guns buried, the protruding muzzles appear to have been hit by powerful moving objects in modern times with sufficient force to have knocked off the muzzle. This hypothesis is supported by the presence of recent leaching visible on the ends of the muzzles: no secondary concretion has yet formed around the freshly broken sections. The concretion covering the chases of both cannon has also been extensively broken off, while continuous concretion covers the first and second reinforces. Re-analysis of the 2008 archaeological record demonstrates that this damage was inflicted before May 2008, when Odyssey first recorded the *Victory* site.

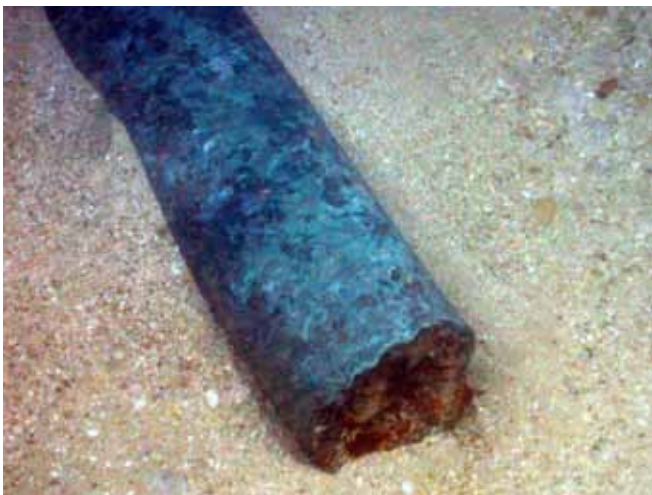
*Figs. 23-25. Bronze cannon C26 in Area G with inconsistent concrete cover: concrete has been knocked off the button, base ring, trunnion, second reinforce and chase (Class C). The muzzle has been completely severed (Class F). This breakage occurred prior to 2008.*

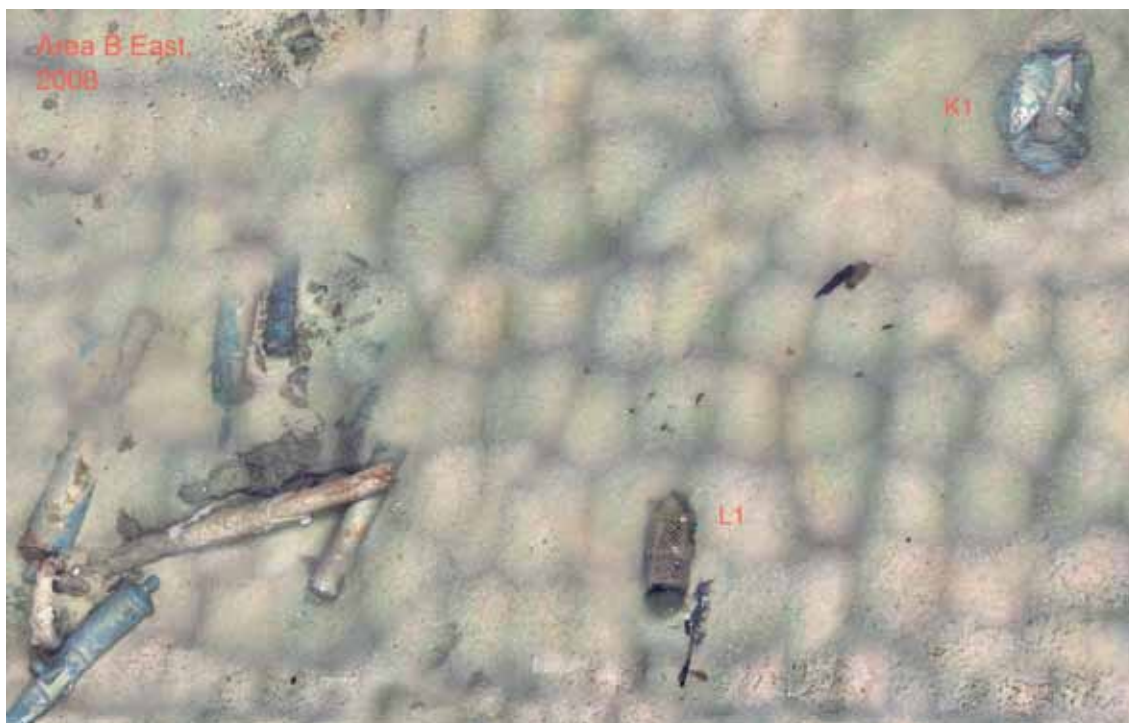
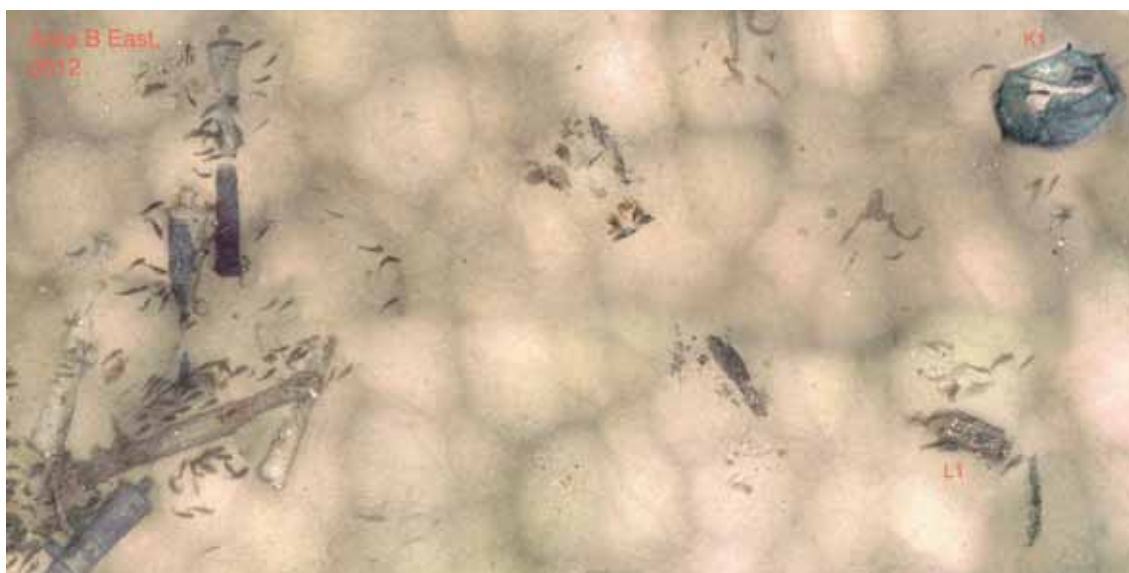
Figs. 36-37. Photomosaic sections of cannon impacts: Area B1 and B2, 2008 and 2012.

Area	Cannon No.	2008	April/October 2011
B1	C20	Bearing 204°, 4.4m southeast of C15.	Not present. (Seemingly relocated 8.5m southwest to Area E, where a new gun was documented in April 2011.)
B2	K1	Copper kettle, north/south bearing 185°, 7.8m northeast of anchor A1.	Orientation changed to east/west axis, bearing 74°.
B2	L1	Lobster/crab, north/south bearing 183°.	Orientation changed to northeast/southwest axis, bearing 112°.

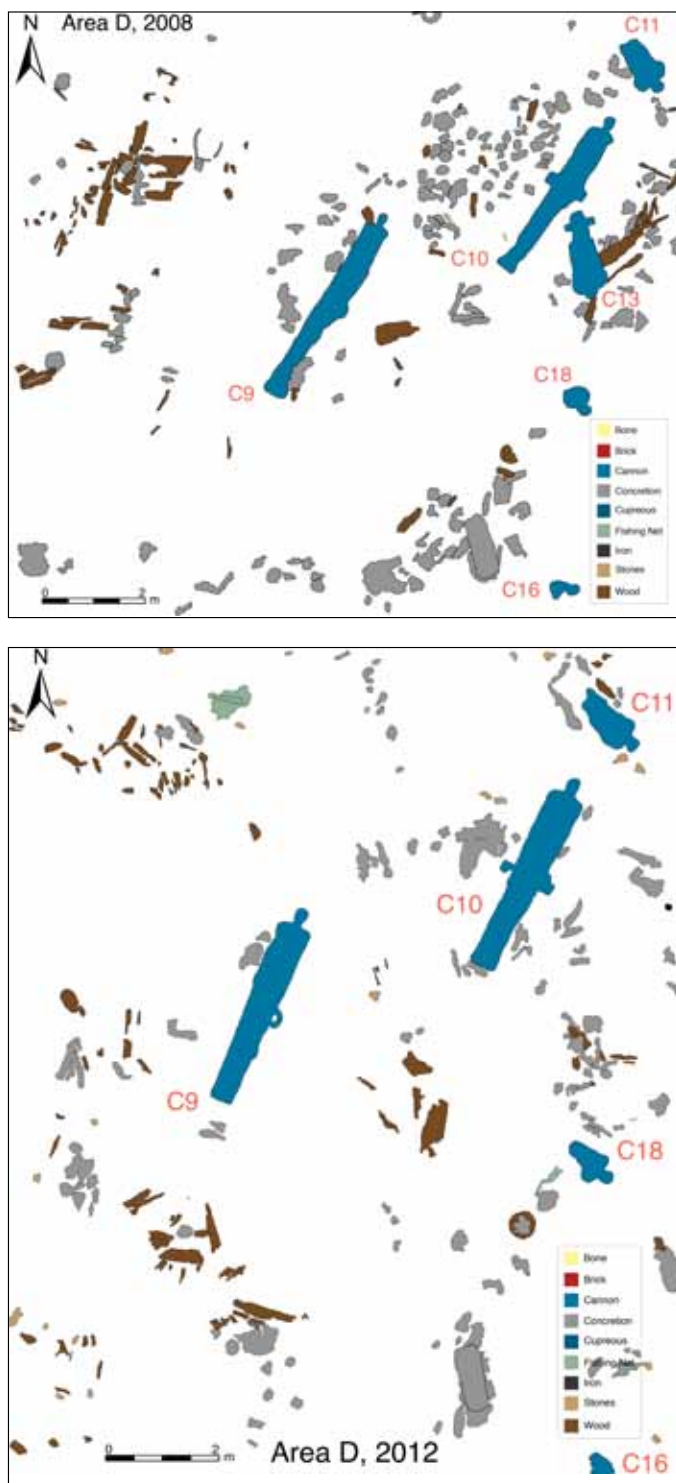
Figs. 45-46. Site plans of cannon impacts: Area D, 2008 and 2012.

Area	Cannon No.	2008	October 2011
D	C13	Bearing 350°, facing north, muzzle underlying C10, 1.3m-long plank at east.	Gun and planking not present.

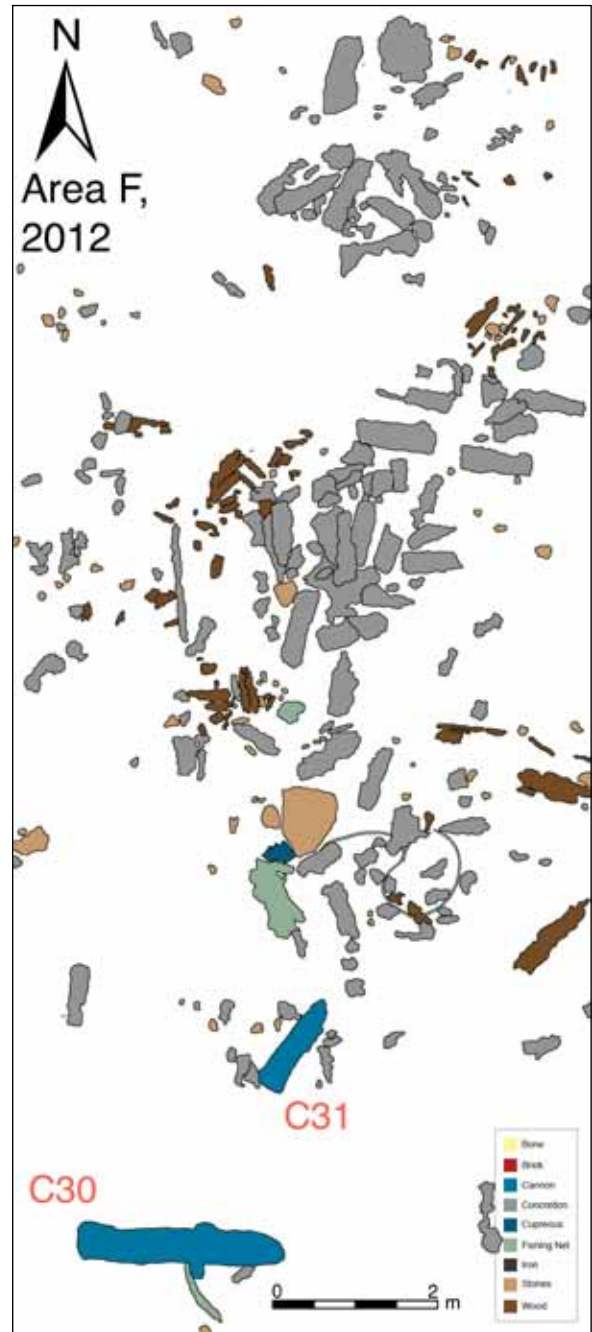
Fig. 55. Site plan of cannon impacts: Area F, 2012.

Area	Cannon No.	2008	October 2011
F	C30	Bearing 285°, facing northwest.	Bearing changed to 273°, gun shunted 2.5m to west.

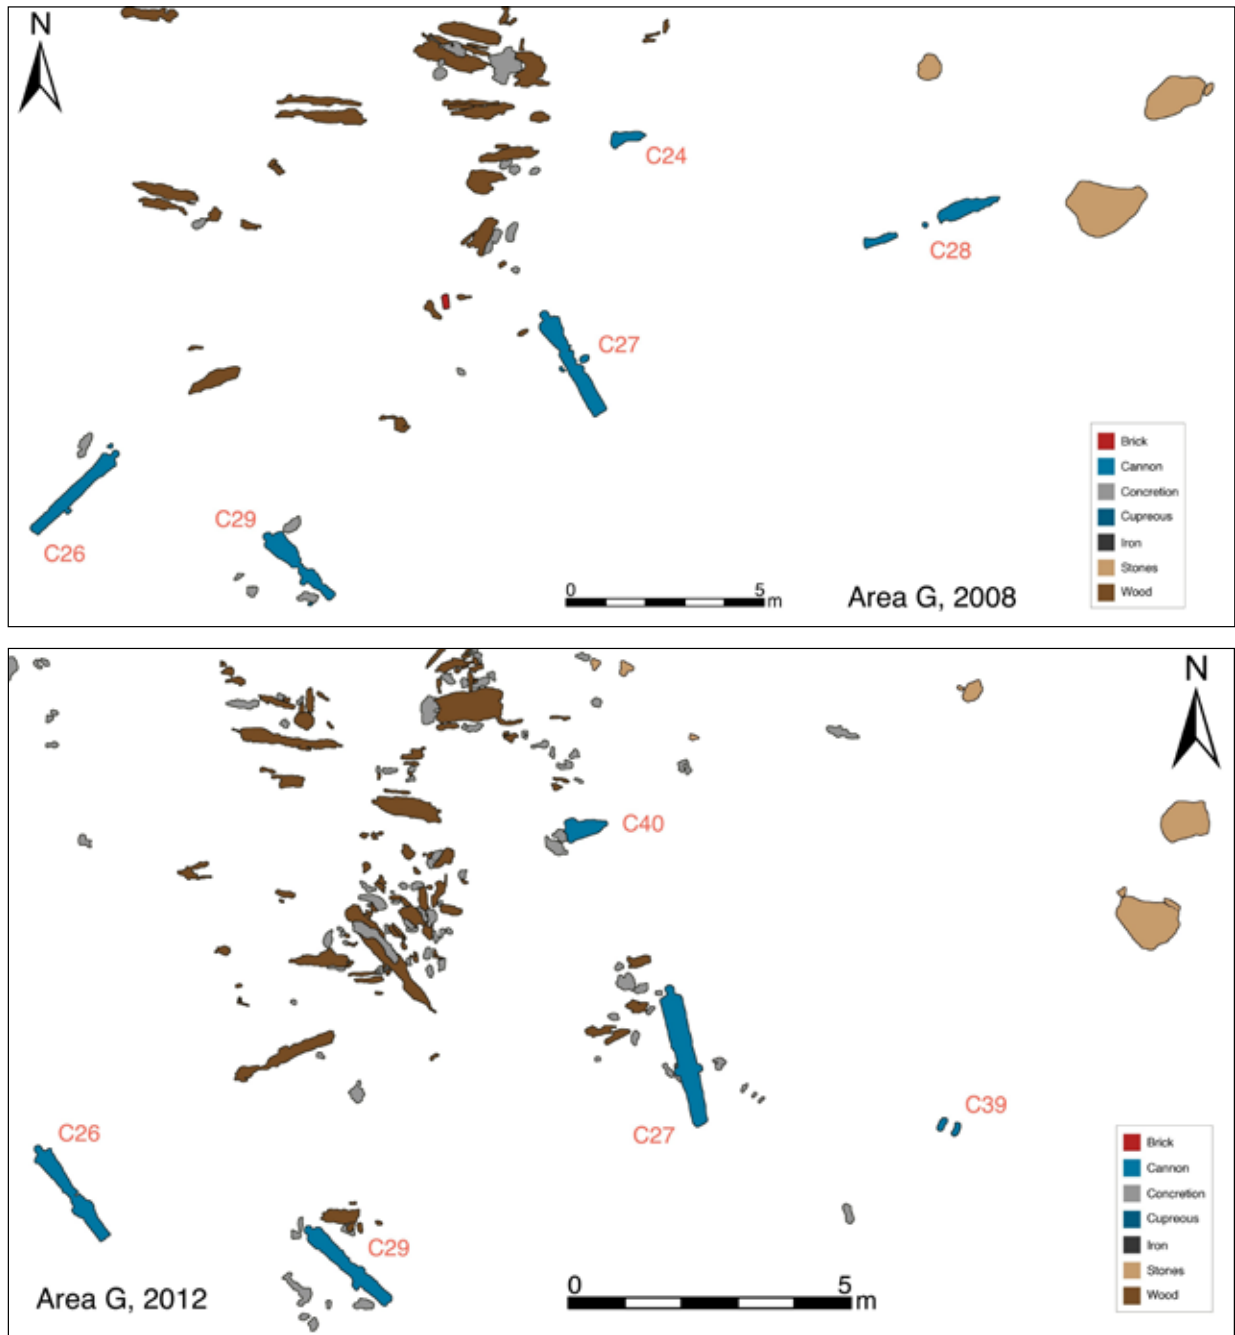
Fig. 58-59. Site plans of cannon impacts: Area G, 2008 and 2012.

Area	Cannon No.	2008	October 2011
G	C26	Bearing 226°, facing southwest, broken muzzle (pre-2008 impact).	Bearing changed to 142°, facing southeast.
G	C27	Bearing 150°, facing southeast, broken muzzle (pre-2008 impact).	Bearing changed to 166°, facing south, flipped 90°, shunted 1.5m to northwest.
G	C29	Bearing 128°, facing southeast.	No change.
