HMS *Victory* (Site 25C). Preliminary Results of the Non-Disturbance Shipwreck Survey, 2012

In 2012, Odyssey Marine Exploration conducted an extensive non-disturbance survey of the wreck of the *Victory* (site 25C), lost in the western English Channel on 5 October 1744. The fieldwork combined visual documentation and recording of surface features with geophysical analyses that included side-scan, magnetometer and multibeam surveys. Two new photomosaics demonstrated that the wreck had been subjected to site-wide impacts since 2008.

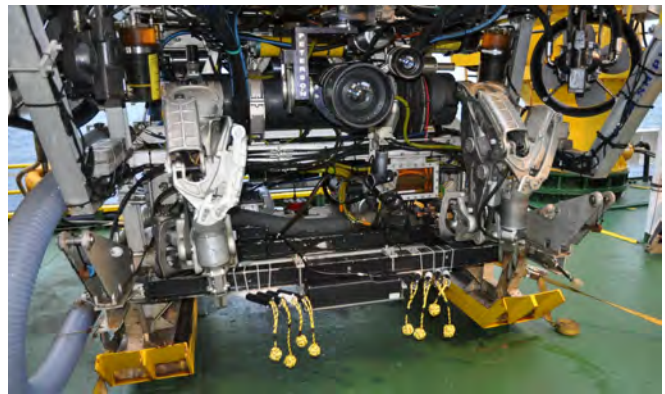
Fig. 1. Multibeam transducers mounted on the ROV Zeus.

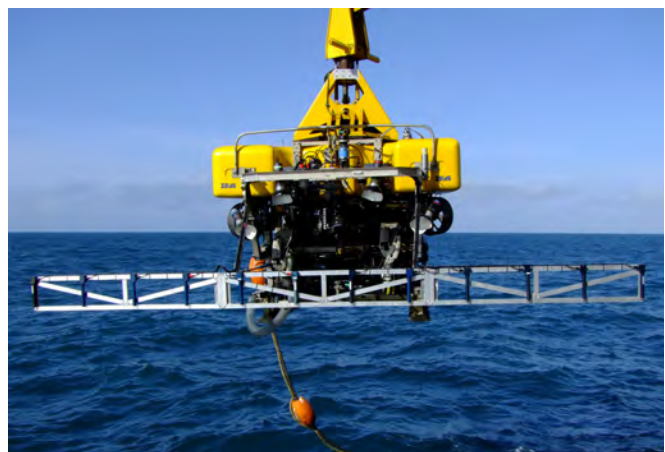
Fig. 2. FADE equipment wings extended in front of the ROV Zeus in preparation for survey.

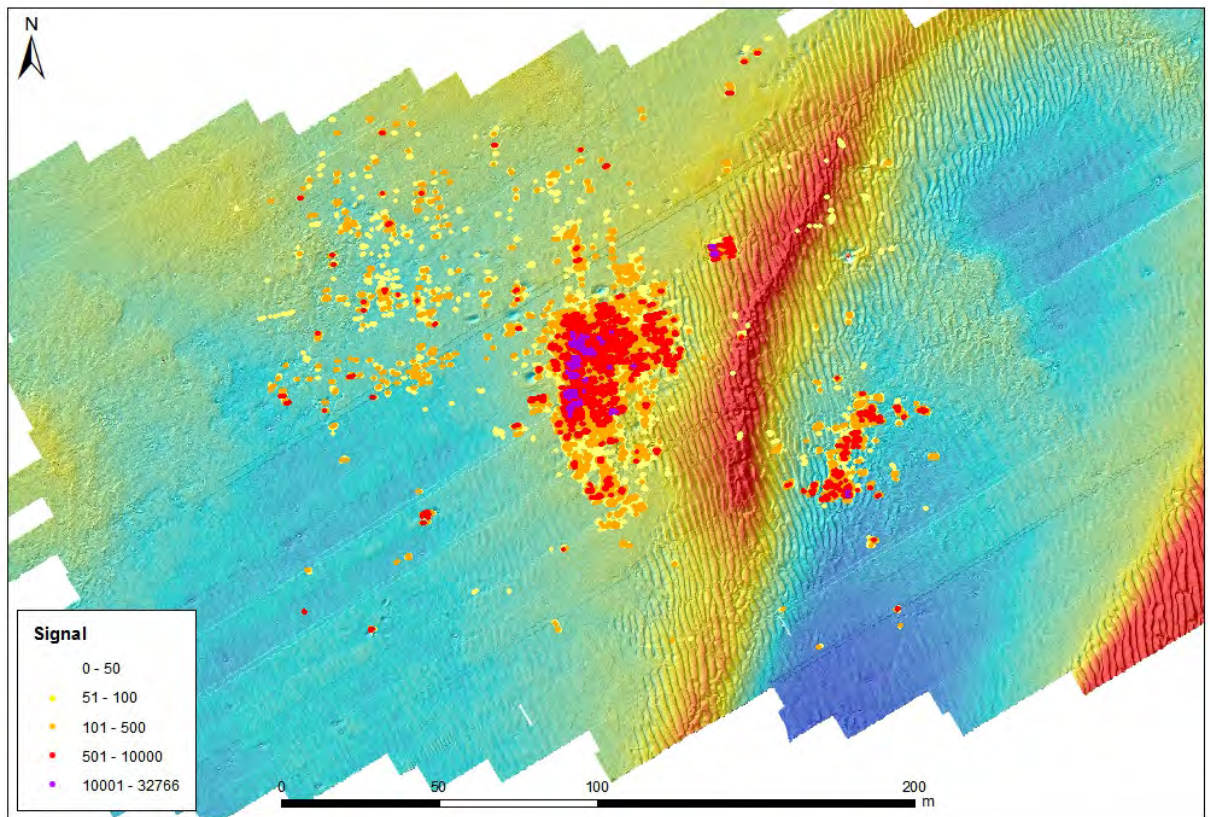
Signal values obtained ranged between 0 and 32,766 (device maximum) and 883,030 data points were measured and plotted as x,y features. Signal values of less than 50 were defined as background noise. Once again, in size, abundance and intensity the anomalies proved to represent a concentration across the main wreck mound. Gridding of the data points and plotting in ArcScene 3D once more revealed a subtle ship-shaped outline (Figs. 19-20).

Fig. 19. TSS magnetometer survey results. Note the scattered readings to the northwest (Debris Field 1) and concentration east of Sandwave 1 (Debris Field 2).

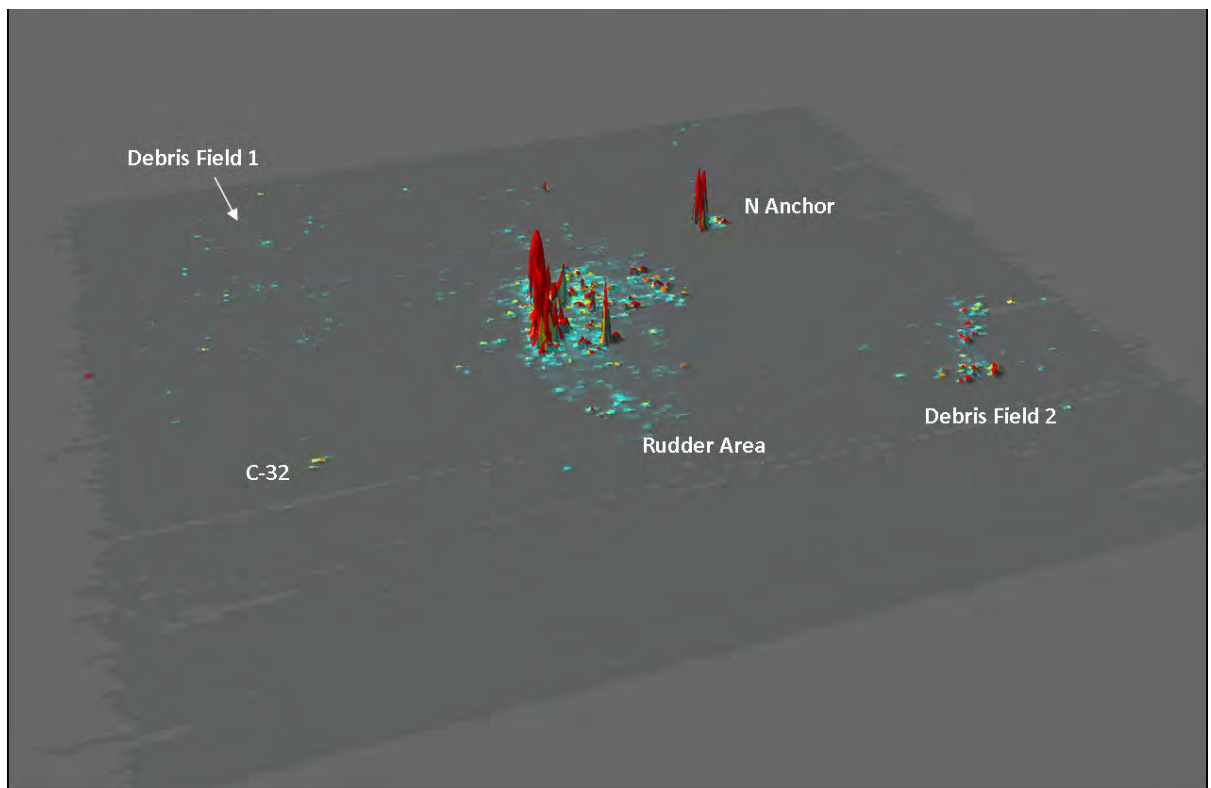
Fig. 20. A ship-shaped wreck profile generated after plotting the 3D TSS magnetometer survey results.

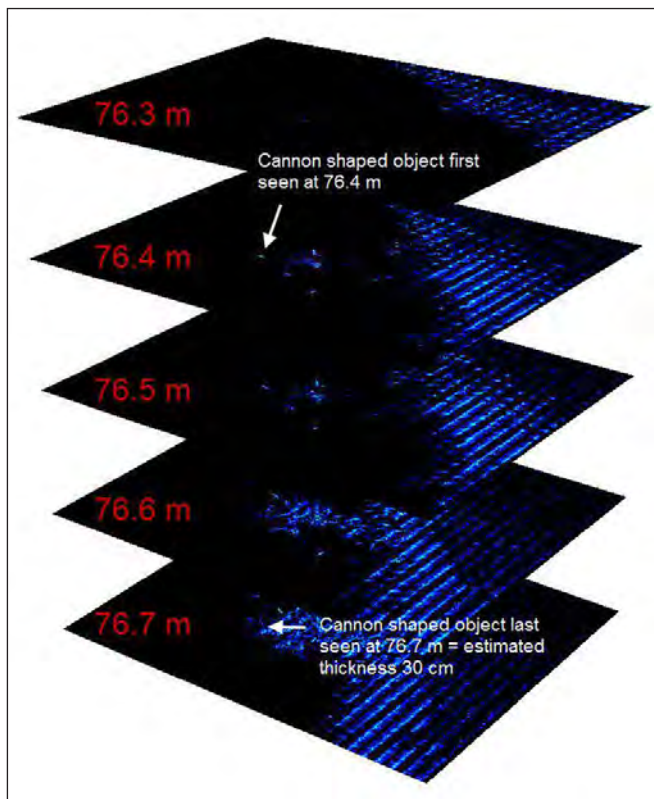
Fig. 21. A 40-centimetre slice through site 25C from the sub-bottom imaging survey shows a probable cannon emerging at a water depth of 76.4m, which is no longer present below a burial depth of 76.7 metres.

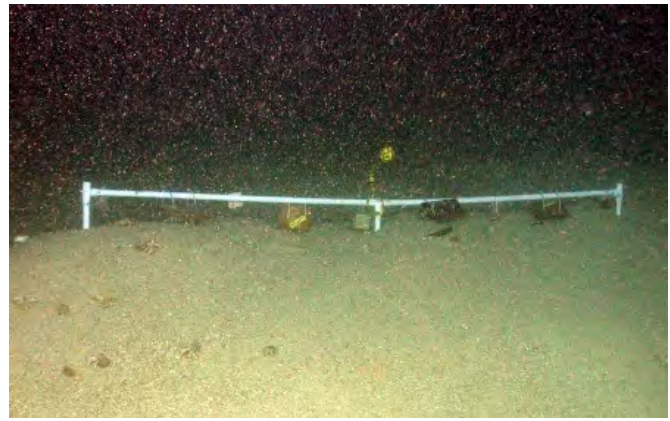
Fig. 38. SF-1 buried at a depth of 72.3m offsite northeast of Sandwave 1.

The sample frames (SF-1, SF-2, SF-3) were transported by ROV to the seabed and deployed 70m northeast of the wreck mound on the eastern flank of Sandwave 1. SF-1 was deployed at 72.3m, SF-2 at 72.5m and SF-3 at 72.0m (Figs. 36-40). The samples' production, form and burial followed the methodology formulated for the RAAR project (Reburial and Analysis of Archaeological Remains: Godfrey, 2009). The Project Design recommended recovery of the samples after six, 12 and 24-month intervals to study degradation processes on these different materials.

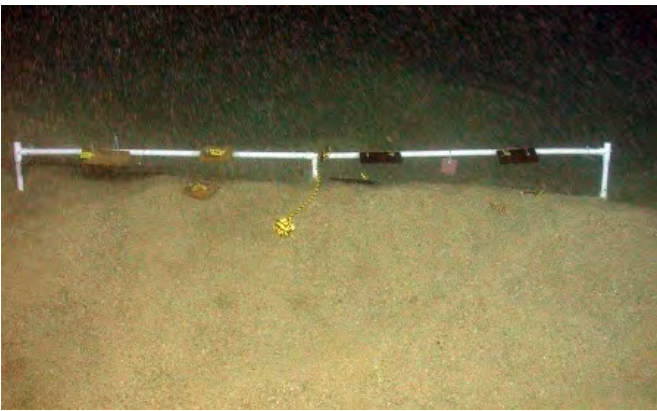
Fig. 39. SF-2 buried at a depth of 72.5m offsite northeast of Sandwave 1.

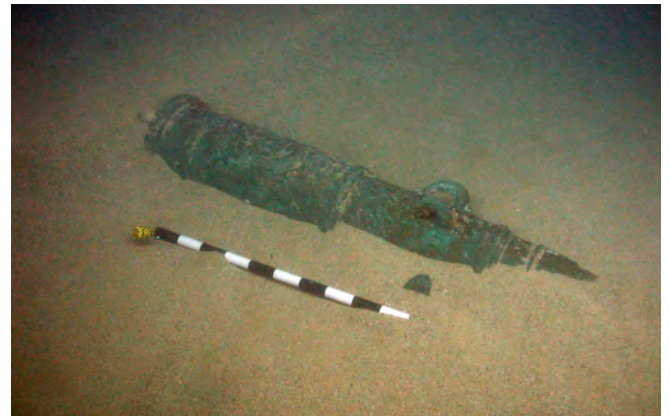
Fig. 41. Cannon C47 discovered during the 2012 side-scan sonar survey 233m northeast of the wreck mound.

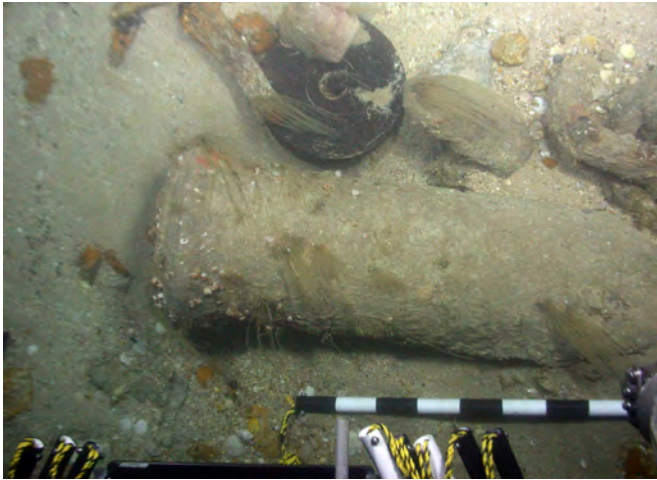
Fig. 45. A wooden sheave block in situ (Phase 1B non-disturbance site survey).

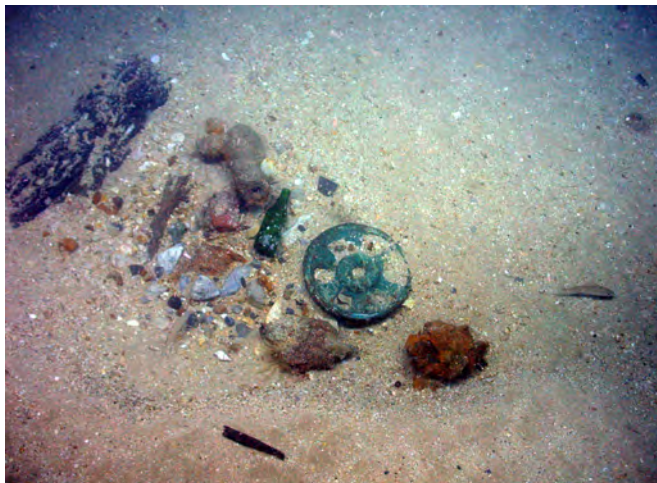
Fig. 47. A bronze sheave (alongside a modern glass bottle) recorded south of Area B1 (Phase 1B non-disturbance site survey).

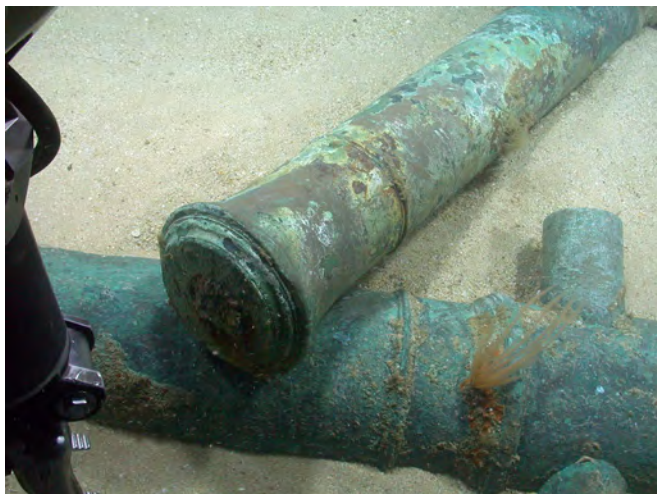
Fig. 48. Bronze cannon C2 (Area A) with its wooden tampion in place (Phase 1B non-disturbance survey).

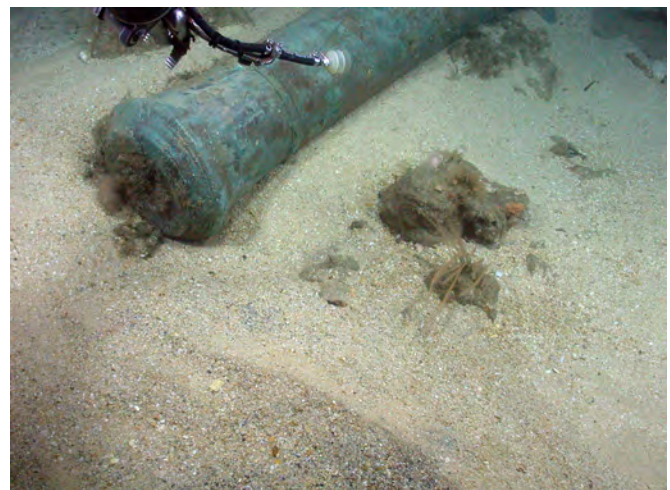
Fig. 51. Bronze cannon C22 (Area E) with its wooden tampion in place (Phase 1B non-disturbance site survey).

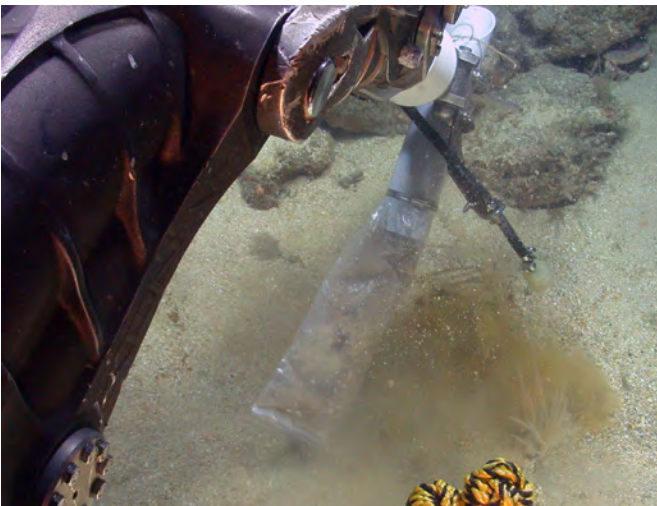
Fig. 53. Sediments being sampled from the top stratum of Area F (Phase 2 non-disturbance site survey).
