## Balchin's *Victory*: Bronze Cannon Conservation Report

Frederick Van de Walle

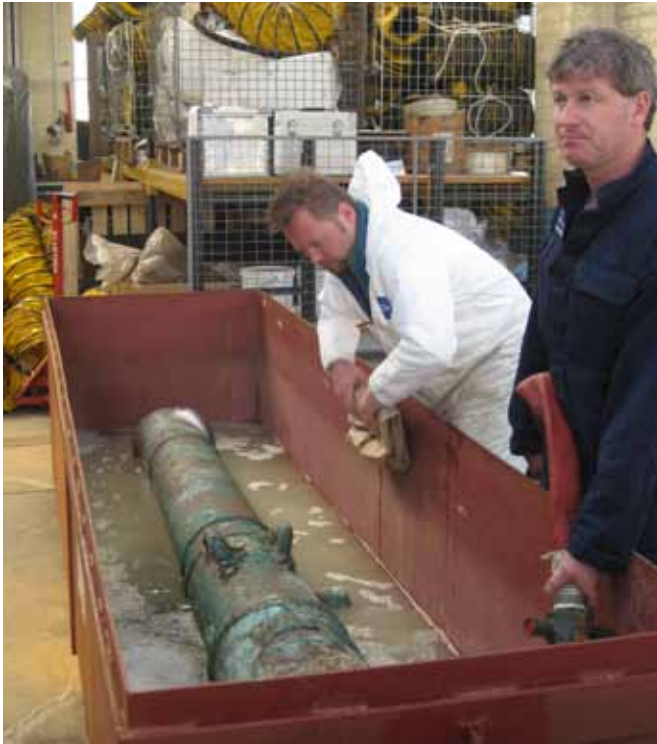
Fig. 1. The 12-pounder bronze cannon C28 undergoing conservation in its tank at Portsmouth Naval Base in 2009.

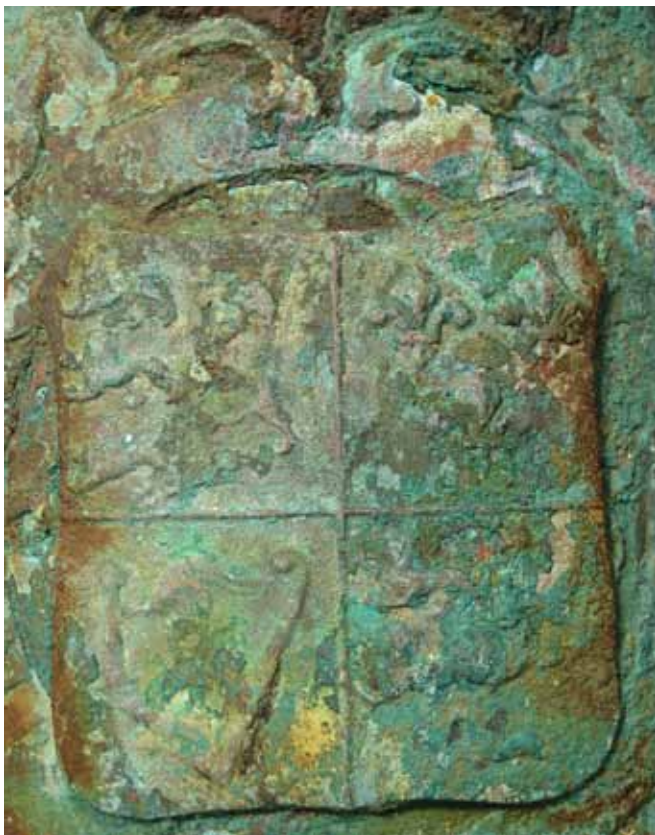
Fig. 4. Detail of the relatively non-encrusted royal arms Of King George I on 42-pounder cannon C33.

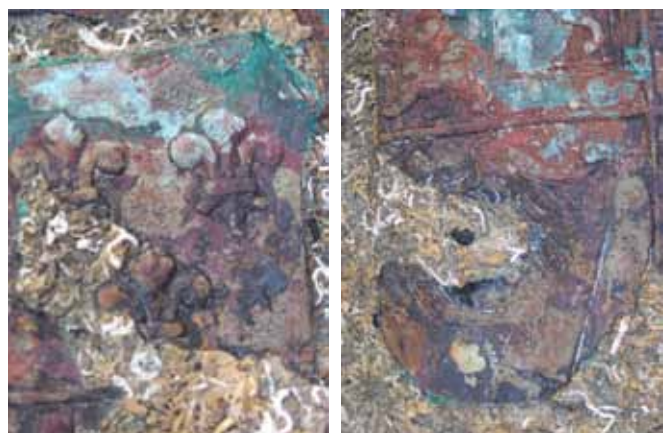
Figs. 7-8. Detail of the fleur de lis, lions and harp within the quadrants on the royal arms of King George II on 12-pounder cannon C28. Note the extensive concretion.

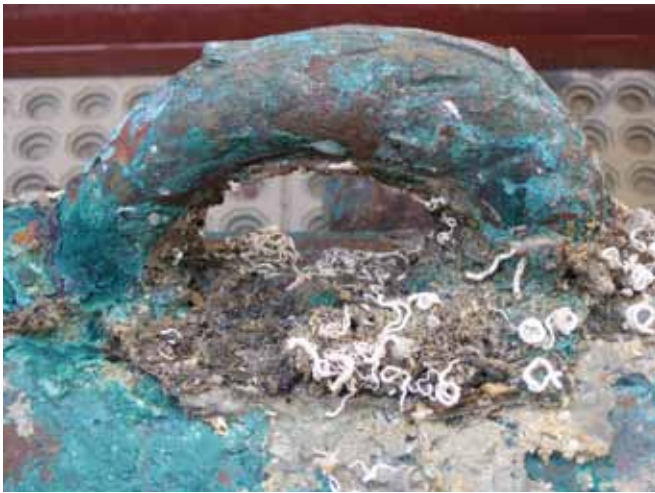
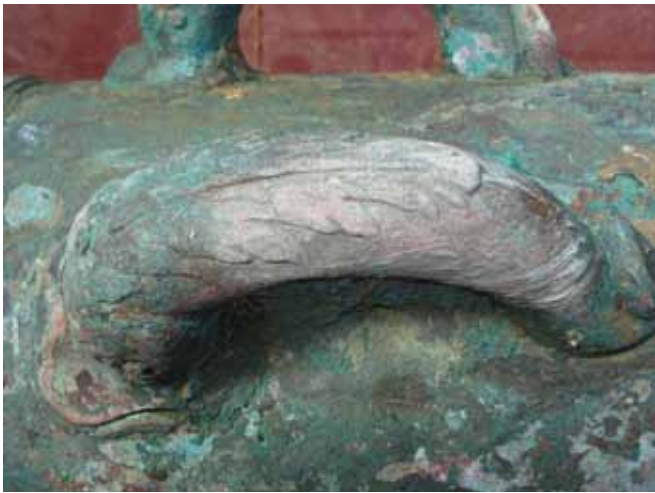
*Figs. 9-10. Dolphin handles from 12-pounder cannon C28 (top) and 42-pounder C33 (bottom). Note the far greater concretion on the former gun.*

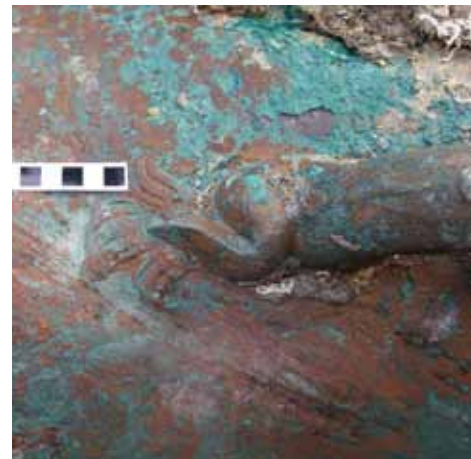
*Fig. 11. Detail of the tail of one of the dolphin handles from 42-pounder C33.*

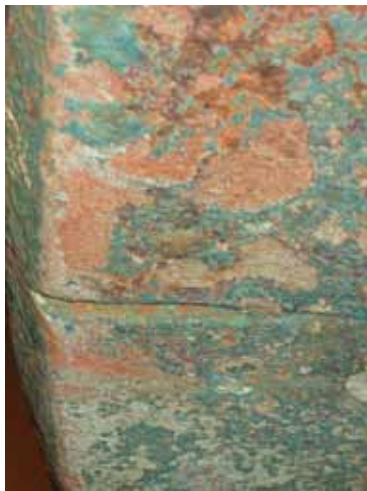
Fig. 15. Early Georgian-era damage to the mouth of 42-pounder C33.

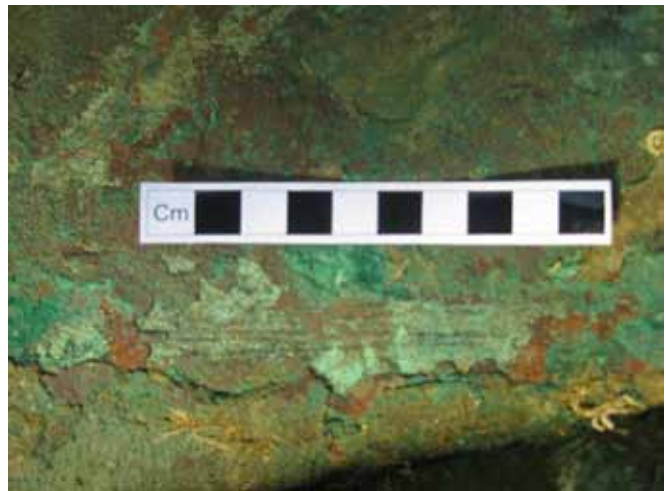
Fig. 16. Delaminated bronze on the surface of 42-pounder C33.
