# Balchin's *Victory* (Site 25C): Shipwreck Monitoring & Cannon Impacts, 2008-2012

Monitoring in 2008, 2011 and 2012 of the wreck of Balchin's *Victory*, lost in the western English Channel on 5 October 1744, and discovered by Odyssey Marine Exploration in 2008, has provided new comparative primary archaeological data about the site's natural deterioration and man-made impacts. In addition to lost sections of hull planking, numerous bronze guns display scratches, abraded surfaces, concretion breakage and have been displaced from their 2008 recorded positions. Two guns feature recently severed muzzles and at least one cannon has been illicitly salvaged since 2008.

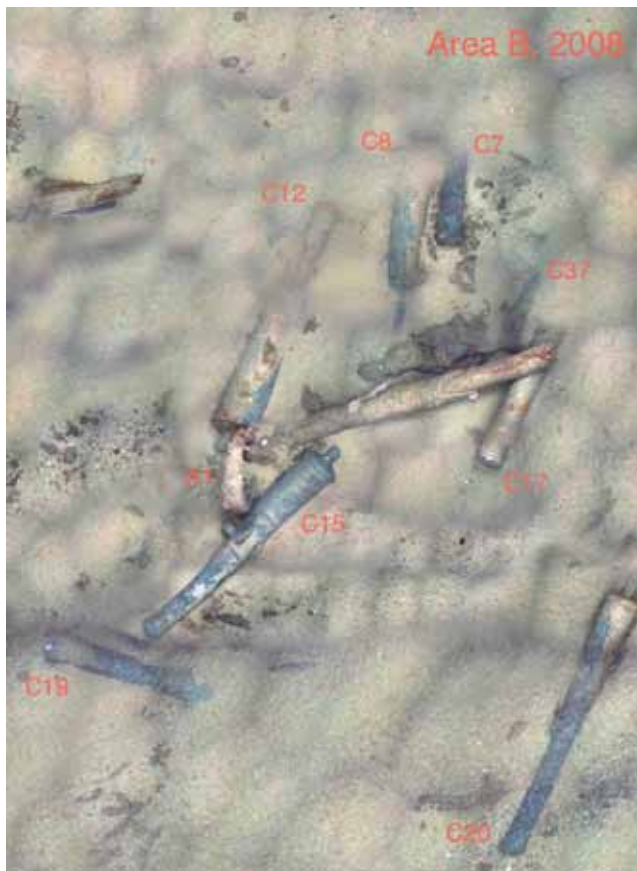
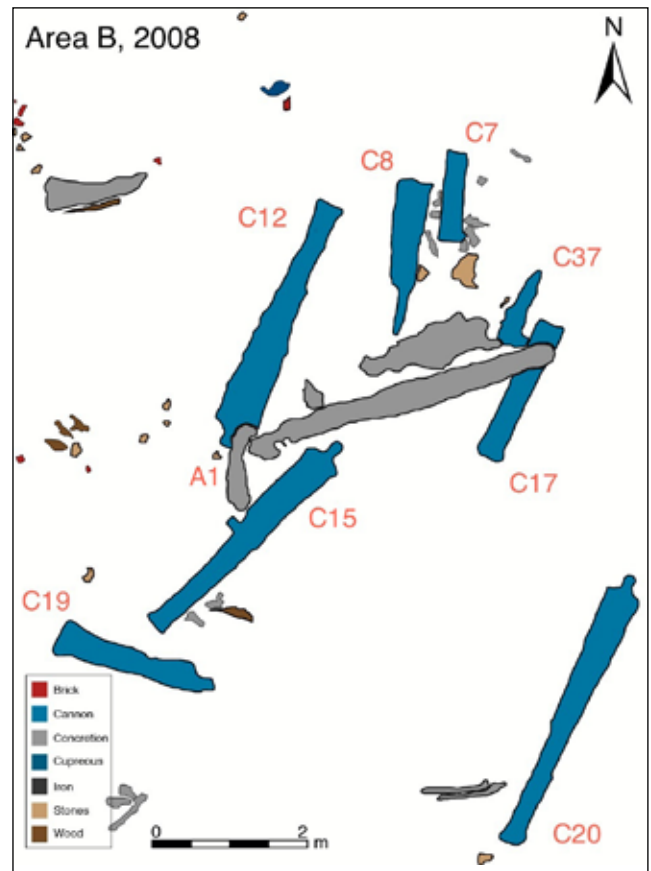
Figs. 32-33. Photomosaic sections of cannon impacts: Area B1, 2008 and 2012.

Area	Cannon No.	2008	April/October 2011
B1	C20	Bearing 204°, 4.4m southeast of C15.	Not present. (Seemingly relocated 8.5m southwest to Area E, where a new gun was documented in April 2011.)
B2	K1	Copper kettle, north/south bearing 185°, 7.8m northeast of anchor A1.	Orientation changed to east/west axis, bearing 74°.
B2	L1	Lobster/crab, north/south bearing 183°.	Orientation changed to northeast/southwest axis, bearing 112°.

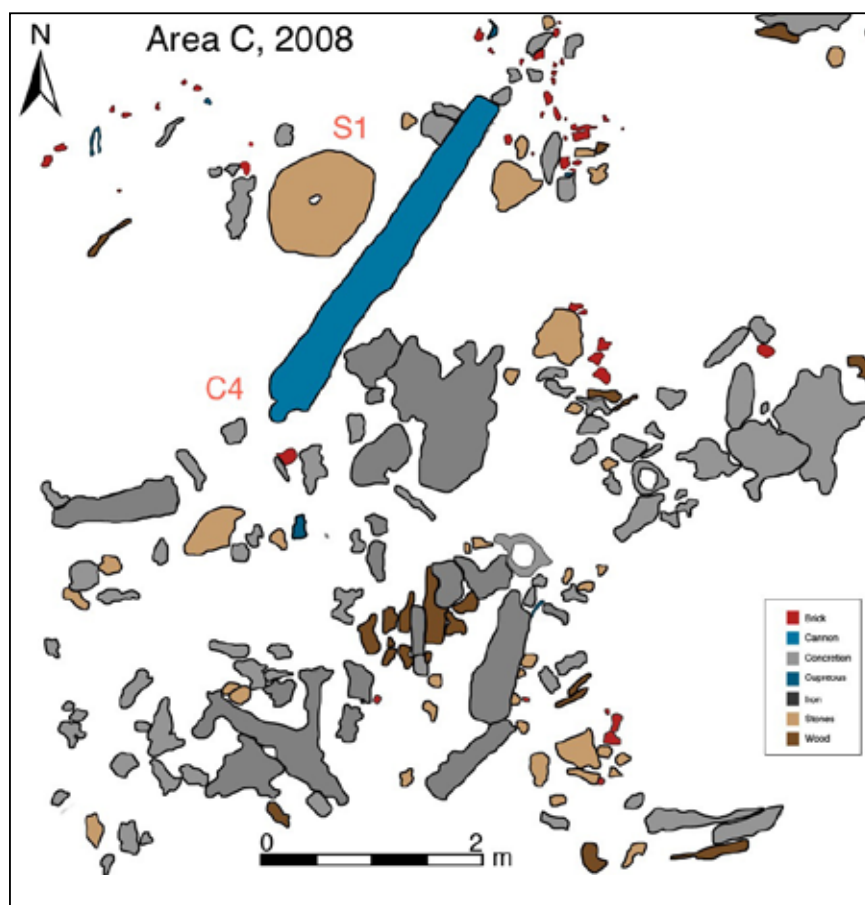
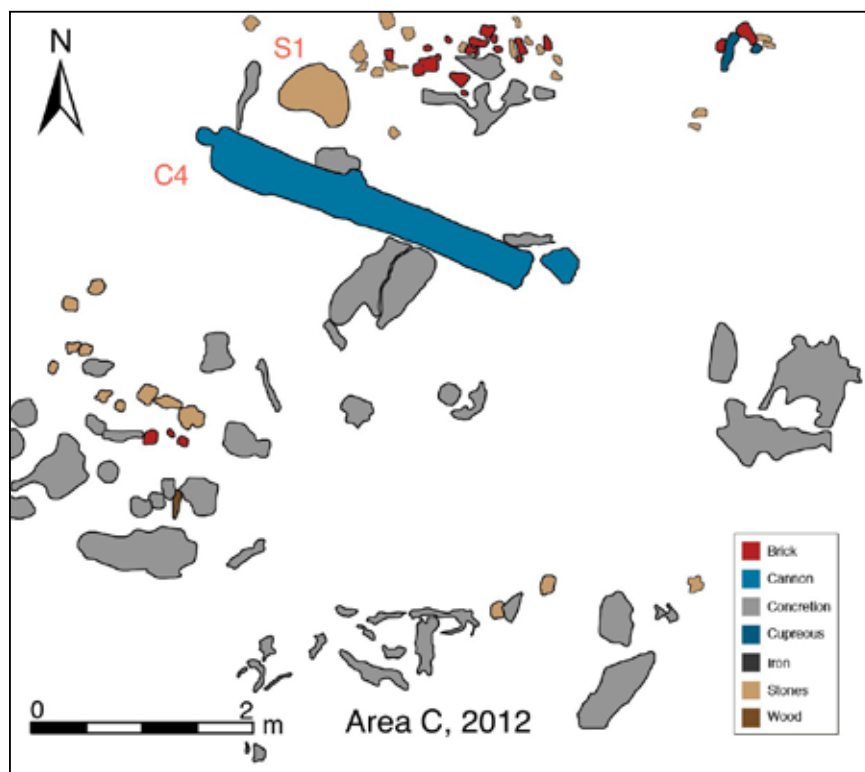
Figs. 38-39. Photomosaic sections of cannon impacts: Areas C1 and C2, 2008 and 2012.

Area	Cannon No.	2008	April 2011
C2	C4	Bearing 35°, facing northeast, stone gunner's wheel immediately to west.	Orientation changed to 112°, facing southeast, gunner's wheel to north.

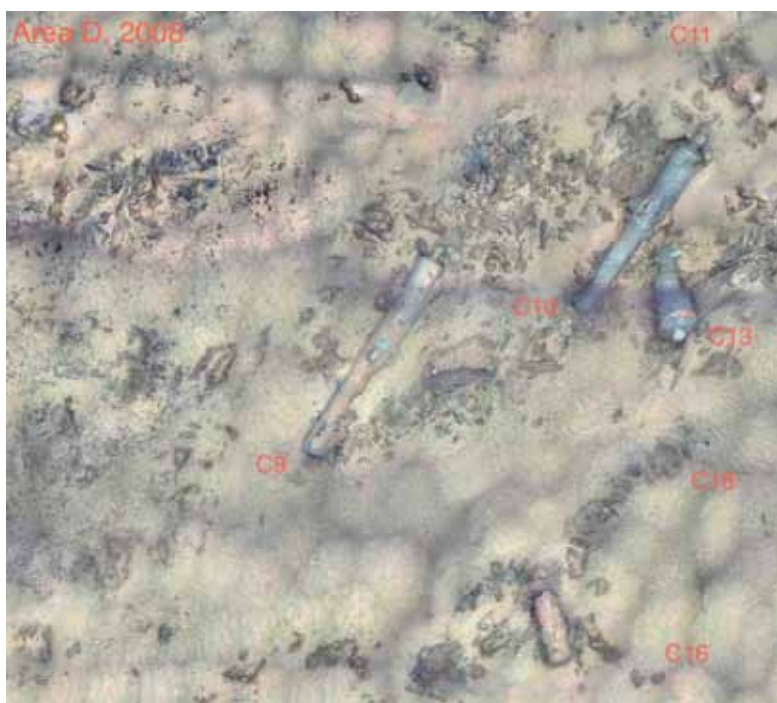
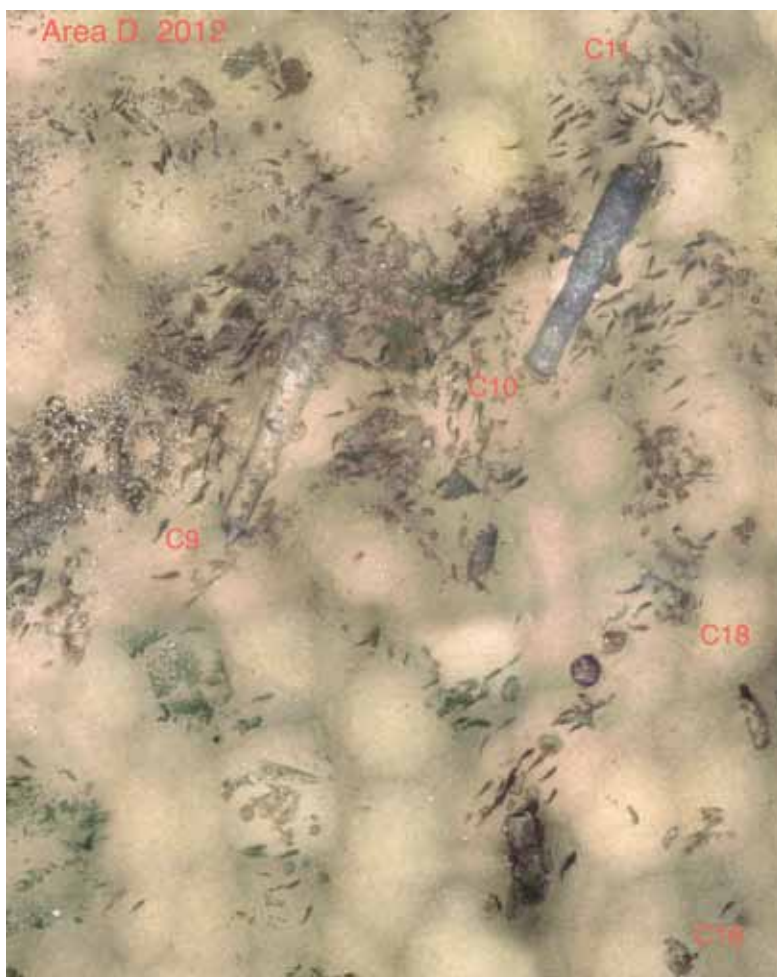
Figs. 43-44. Photomosaic sections of cannon impacts: Area D, 2008 and 2012.

Area	Cannon No.	2008	October 2011
D	C13	Bearing 350°, facing north, muzzle underlying C10, 1.3m-long plank at east.	Gun and planking not present.

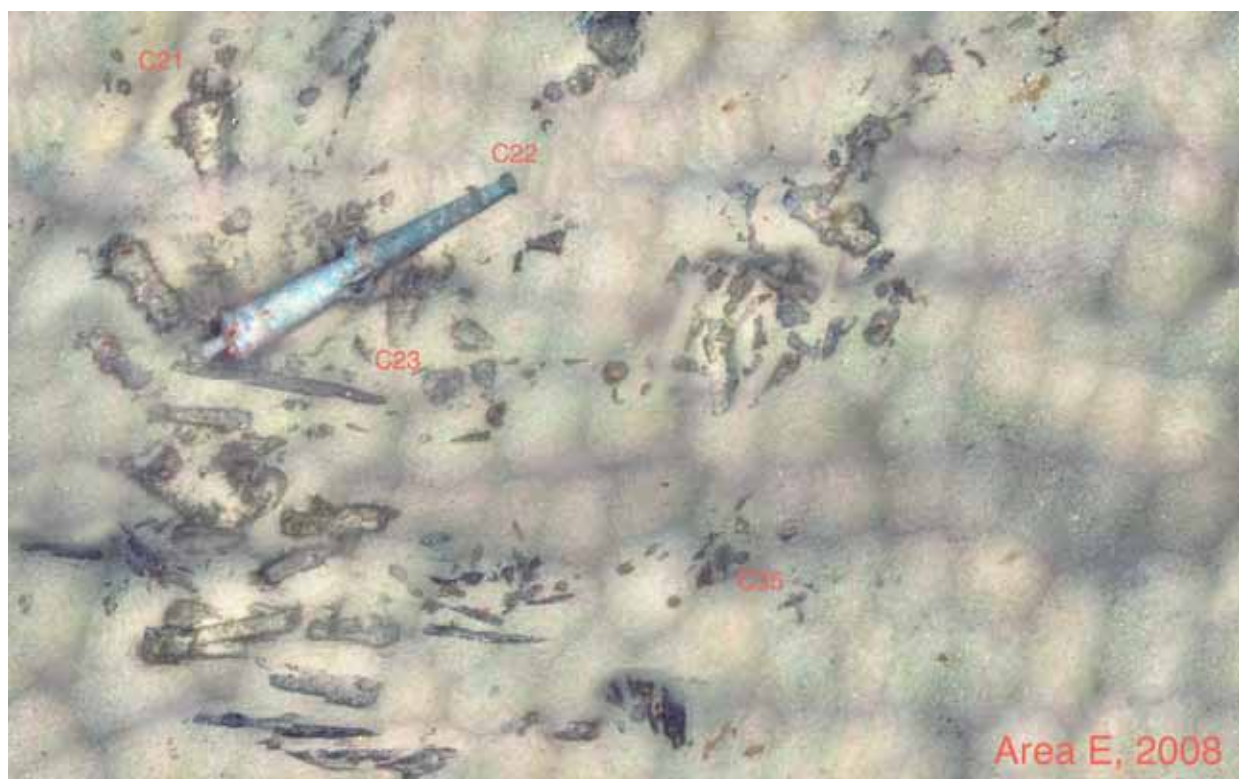
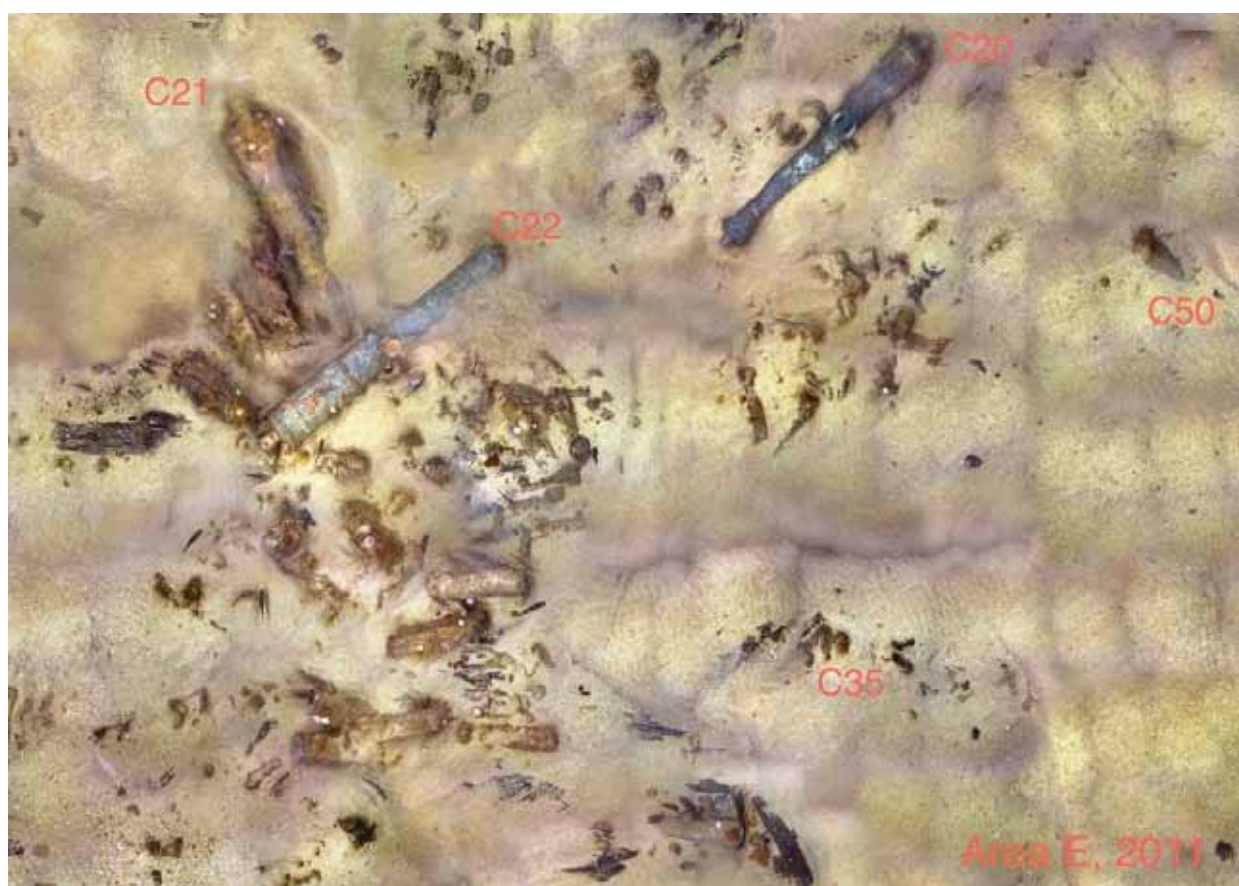
Figs. 47-48. Photomosaic sections of cannon impacts: Area E, 2008 and 2011.

Area	Cannon No.	2008	April 2011
E	C20	Not present.	New cannon, bearing 239°, facing southwest, heavily scoured chase. Believed to be C20 relocated 8.5m from northeast in Area B1.
E	C21	Bearing 168°, facing south, muzzle underlying C22 breech and vent field.	Rotated 45° to west bearing 158°, muzzle underlying C22 second reinforce.
E	C22	Bearing 63°, facing northeast, breech and vent field overlies C21 chase; 2.7m-long wooden spar immediately at south.	Rotated 90° to southeast bearing 56°, second reinforce overlies C21 muzzle. Gun shunted 1.5m to southwest. Wooden spar not present.

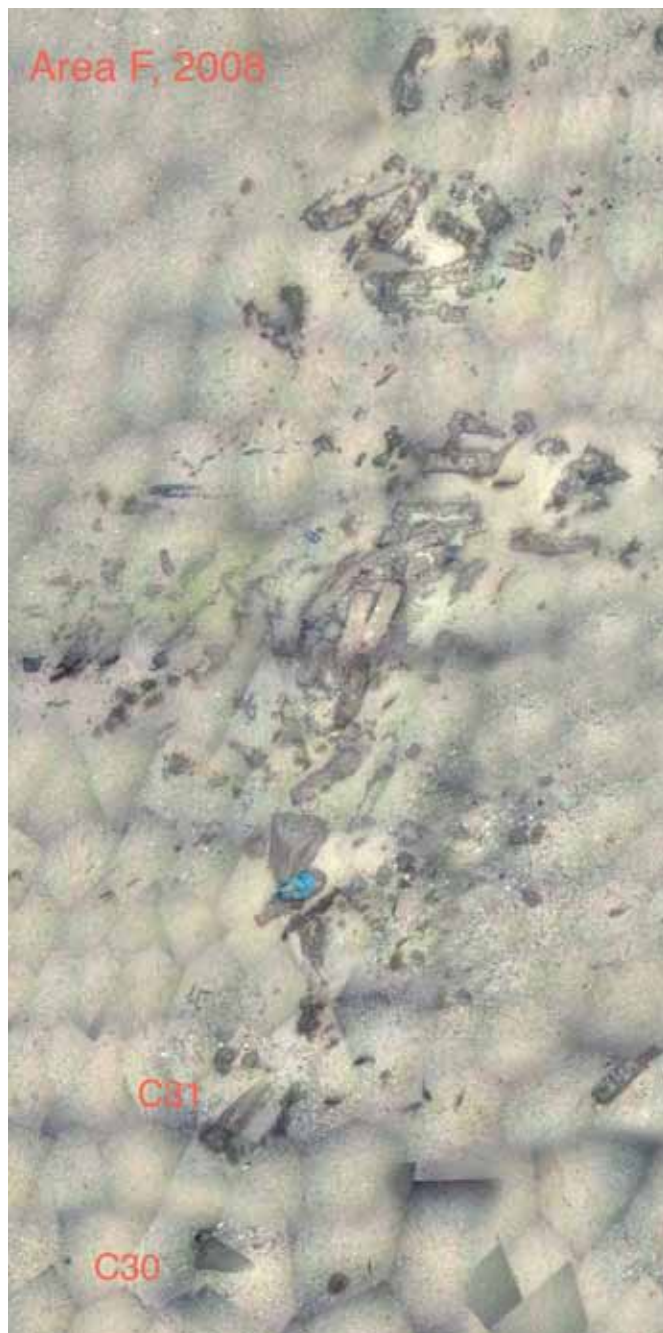
Fig. 52. Photomosaic section of cannon impacts:  
Area F, 2008.

Area	Cannon No.	2008	October 2011
F	C30	Bearing 285°, facing northwest.	Bearing changed to 273°, gun shunted 2.5m to west.
